Manhole Inspection Summary

Manhole # S07II2013MH

Insp Date: **7/6/06 11:02 AM**

Location Address: **6311 PIMILICO RD** Cross Street: **SHELLEYDALE DR**

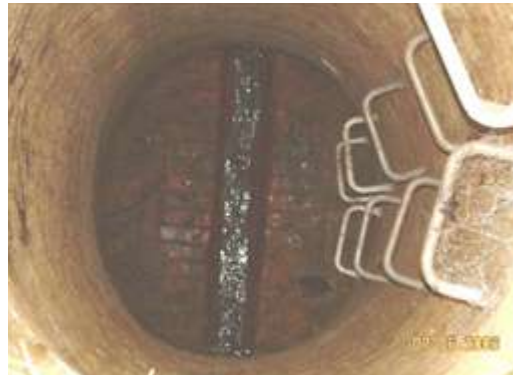
Top View

Frame Offset: **0** (in.) Condition: ☐ Sound ☐ Cracked ☒ **Leaks**

Frame Leak

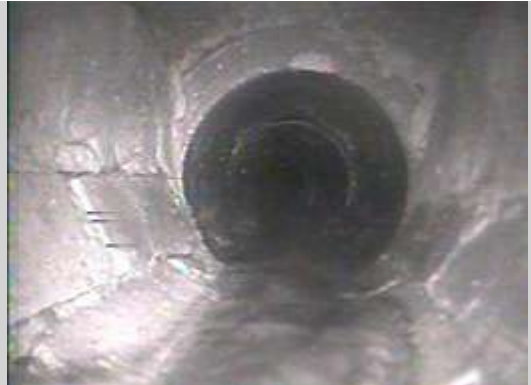
Rod and Bar (Angled)

8 in. Circular Gravity Sewer Pipe Out @ 12 O'Clock

Pipe Material: **Clay** ☐ Pipe Lined

Invert Depth: **15.65** (ft.) Flow Characteristics: **Slow**

Infiltration: **None** Pipe Seal Cond: **Unknown**

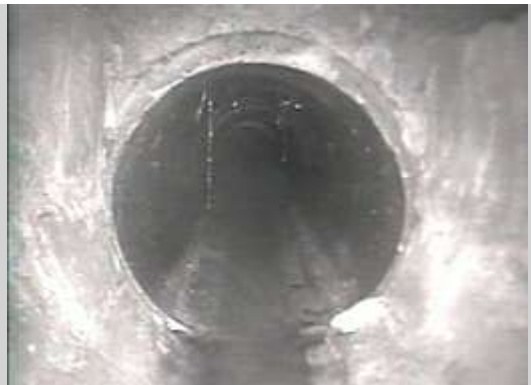
Rod and Bar (Angled)

8 in. Circular Gravity Sewer Pipe In @ 6 O'Clock

Pipe Material: **Clay** ☐ Pipe Lined

Invert Depth: **15.51** (ft.) Flow Characteristics: **Slow**

Infiltration: **None** Pipe Seal Cond: **Unknown**
